CONTRIBUTION FOR CIGRE SC12/A2- MERIDA- KOLLOQUIUM

TRANSFORMER LIFE MANAGEMENT GERMAN EXPERIENCE with CONDITION ASSESSMENT

4. GERMAN EXPERIENCE FOR CONDITION ASSESSMENT IN POWER TRANSFORMERS

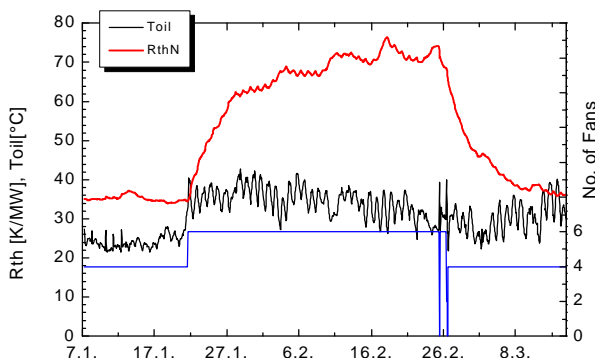
Fault Symptom: Increase of thermal resistance

On-line monitoring of the cooling unit of a 420kV / 600MVA grid-coupling transformer by calculation of the nominal thermal resistance R_{th} as described in [11,12] showed a strong increase after switching on of two additional fans which was signalled by the control system. This increase triggered a warning message by the monitoring system. A local check in the substation revealed that due to a failure of energy supply only half of the cooling unit (3 fans) was in operation and therefore only three fans were running. This status was not in accordance with the information of the control system and led to the strong increase of nominal thermal resistance. With the present load and half of the cooling power the transformer could be kept in service. But it would not be possible to operate the transformer with nominal load due to the missing cooling power. This scenario shows the importance of detecting also minor failures to avoid the risk of not delivering energy.

Fig. 1: Abnormal condition of cooling unit detected by increase of thermal resistance R_{th}

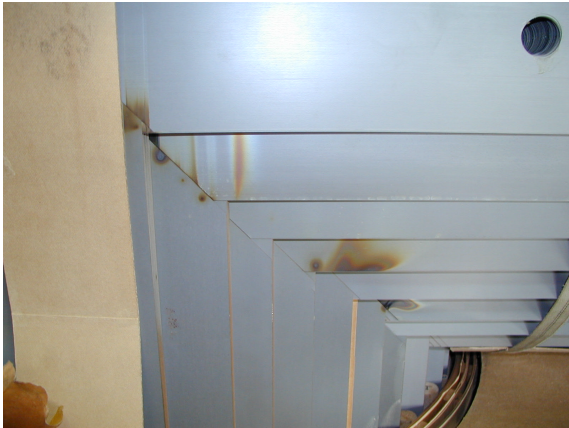
The rectifier was returned to the factory for repair. A core burn (See Fig. 2) as a consequence of a transport damage was the source of the abnormal circulating currents in the core. The core has been repaired.

Diagnosis: Core burn as a consequence of high circulating currents.

Fig 2: A severe core burn as a consequence of high circulating currents

Action taken: Repair of the core and introduction of magnetic shielding.

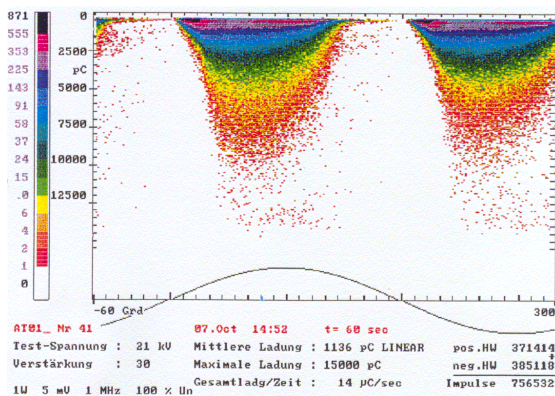
To clarify this, a RVM and a frequency-dependent impedance measurement were performed but without any defect indications. Then on-site partial discharge measurements were made by a PRPDA (Phase Resolving Partial Discharge Analyser). Two partial discharge sources of the same kind were clearly indentified at phase V and phase W (Table 5, Fig. 3).

Fig 3: Example of PD Activity at Phase W (HV)

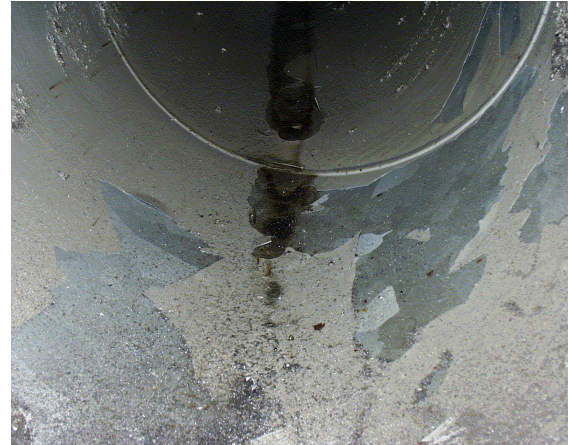
The discharges were caused by the particles from the inner coating of the tubing (Fig. 4) of temporary connected cooling plant.

Fig 4: Paint particles from the cooling plant, causing PD

Diagnosis: Severe contamination of all windings from the piping of a cooling plant, with severe PD tracking.

Action taken: Repair. New windings and cleaning of the cooling plant.

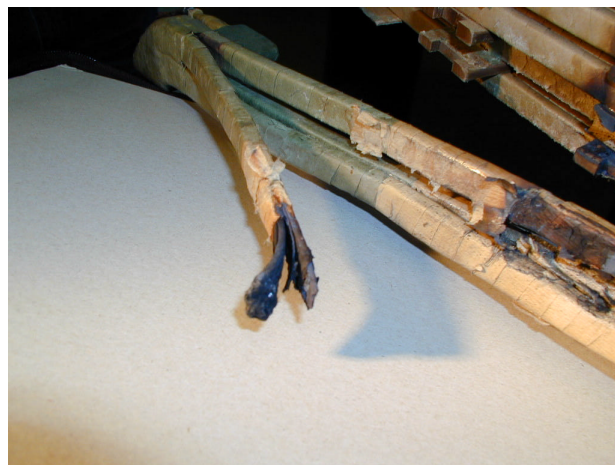
One broken twin conductor of two twins with burnt out insulation paper was detected. The damage location was a defective solder joint. The damage location has been a localized thermal source, because the DP-value of neighbouring insulation paper was not affected.

Fig 5: A broken twin conductor as a consequence of a defective solder joint

Diagnosis: Defective solder joint

Action taken: The winding was repaired and the transformer was taken in service again and is working troublefree.

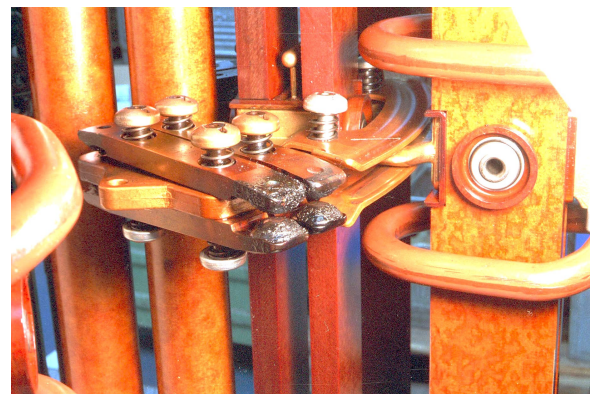
any current dependency. However, unusually high and unstable contact resistances were determined at the change-over selector. For this case a special surface resistance measurement was developed. Even after an increased number of change-over selector operations, the resistance values did not show any improvement. This behaviour indicated quite a heavy coke layer on the contacts, which could not be removed by simple switching. The transformer was opened, the selector was inspected and the change-over contacts were exchanged. The change-over contacts were covered with a thick carbonized layer with a significant surface erosion – see Picture. Such contact damage mainly appears on change-over selectors made of copper (movable contact) and brass (fixed contact) which are rarely operated. Caused by the slight tarnish, the contact resistance increases, and, consequently, the temperature of the contacts, too. The increased contact temperature accelerates the growth of tarnish and the temperature is high enough to decompose the oil and oil carbon is generated (Fig 6). In the course of time heavy layers (oil carbon) will be built up.

Fig 6: Eroded contacts of the tap selector with a coke layer.

Diagnosis: Oil-carbon layer on the copper and brass selector-over contacts.

Actions taken: Exchange of the contacts, on-site repair with consequent oil degassing.

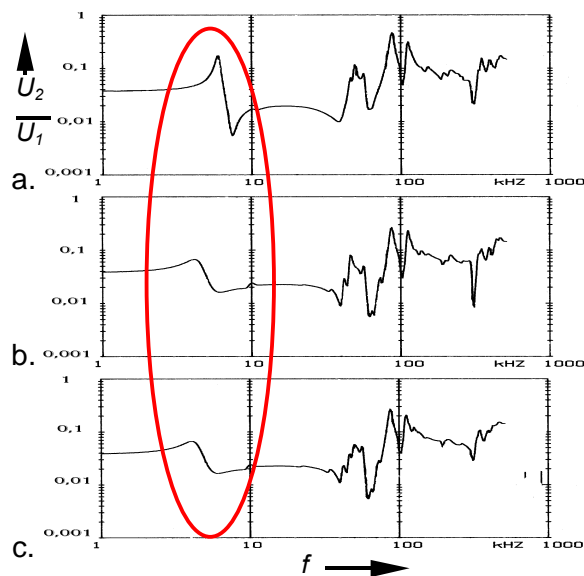
was analyzed in the frequency domain (Fig. 7) and it clearly showed a significant deviation for phase U against Phase V and W. This clearly coincides with the defect found during disassembly.

Diagnosis: DGA, interdisc short circuit at 2nd/3rd disc at the ground side of HV winding with a secondary effect of an axial flashover due to excess gas generation.

Fig 7: Transfer Function Analysis of a 175 MVA/520 kV GSU Transformer

Actions taken: Due to the heavy contamination of carbon the complete set of phase windings on phase U/LV/HV regulating winding was replaced.

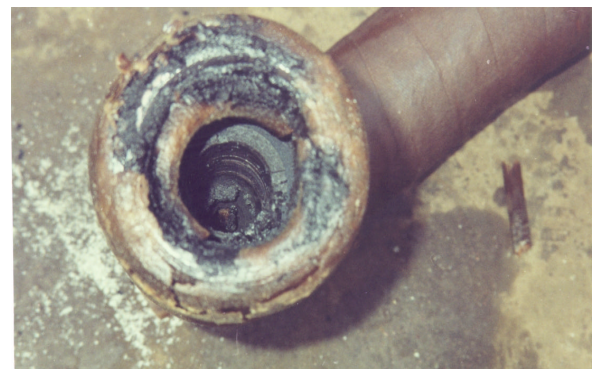
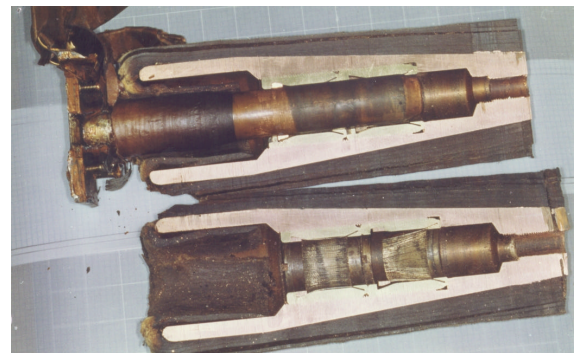
The DP values of the insulation at the connectors was between 150-250, i. e. It has reached its end of life (Fig 8a and b). The DP values on the low voltage lead was 500 -600. Since this is a GSU of a nuclear power plant no further risks were taken and the unit was replaced by a new transformer in 1993.

Fig. 8a, b : Connectors with fully burnt out solid insulation

Diagnosis: Overheating of the connectors because of stray currents and consequent degradation of the cellulosic insulation.

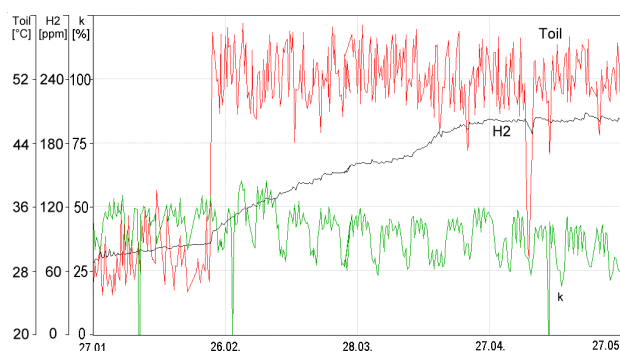
A 400kV/300MVA grid coupling transformer was put into operation after repair with a new active part and installation of an on-line monitoring system. After commissioning the content of hydrogen detected by the on-line monitoring system increased continuously (Fig. 9). An increase of oil temperature by special control of the cooling unit revealed that the concentration of hydrogen is only dependent on the oil temperature. A correlation with the load factor k could not be detected. Therefore, an abnormal condition like partial discharges or hot

spots due to load current could not be possible. The reason for the generation of hydrogen is due to chemical reactions of the new transformer oil [10]. This behaviour during a transformer's initial operating period has become apparent as on-line monitoring has become common, and it has probably always occurred. Gas formation is most apparent in highly refined oils, probably because the hydrogen and hydrocarbon radicals there cannot react with any unstable structures, since there are no such structures. Also zinc in the pipes of the cooling unit can cause such an increase of hydrogen. An off-line dissolved gas analysis (DGA) to determine the concentration of the other components dissolved in the oil indicated no further gases than hydrogen. So evaluation of several variables by the monitoring system revealed that the generation of hydrogen is caused by chemical reactions and therefore in this case uncritical.

Fig. 9 : Hydrogen content dependent on top oil temperature
