EVALUATION OF TRANSFORMER RELIABILITY DATA BASED ON NATIONAL AND UTILITY STATISTICS

Janine Jagers^{1*} and Stefan Tenbohlen²

Abstract: Statistics about failures of power transformers constitute an important basis for asset management of a fleet of transformers. Periodic review of failures statistics becomes necessary where they can be used to influence transformer design and technology, maintenance and condition monitoring practices with changing system loading, operation and network configuration. This paper provides the process of statistical data acquisition and evaluation based on the German failure statistics and the results of an investigation of failed transformer units in South Africa, demonstrating the level of insight a detailed failure study can provide into the performance of a large transformer fleet.

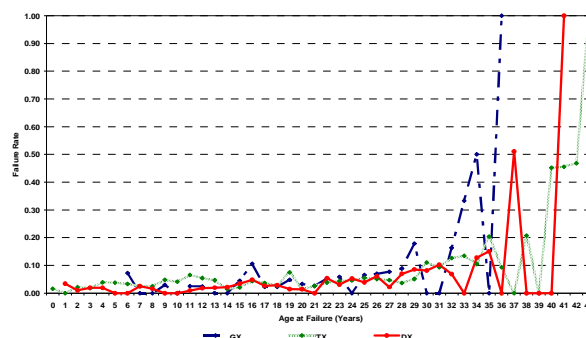
Figure 1: Hazard function for GSU, transmission and distribution transformers

Although the hazard function in Figure 1 indicates failures starting in early life in all three groups of transformers, with the onset being at 6 years in GSU transformers, no periods of particularly high failure

rates could be observed in early life that could possibly indicate design or manufacturing problems. However, the GSU failure rates are higher than that of the other groups in this period. From the hazard function in Figure 1, an increasing failure rate with age is observed across all three groups of transformers.

Lower failure rates are observed up to 21 years age in the GSU and distribution transformers, representing normal transformer life. After 21 years there is an increase in failure rate with age, with a sharp increase after 28 years in GSU transformers, which could be attributed to wear out, general ageing of components and end of life. In the transmission units wear out also sets in after 28 years in-service.

A major contributing cause to the failure of older units from 25 years onward, as suggested by the hazard function in Figure 1, is the wear out and general ageing of components. The fact that GSU transformers are running at full load most of their operating time further increases the aging process. Operating conditions are detailed with the design specification, thus the ability to withstand these stresses should be built into the design. Abnormal deterioration, or accelerated ageing was evident in a few units in the age group 13 to 22 years, with most of the failures resulting in inter-turn short circuits due to insulation degradation.

According to the hazard function in Figure 1 after 28 years in service, wear -out and general ageing becomes a major contributory cause to failures and is evident from the increase in failure rate. The impact of accelerated ageing, or abnormal deterioration was evident in units from 9 years in-service originating in the bushings, turn-to-turn insulation of the windings and tap changers.

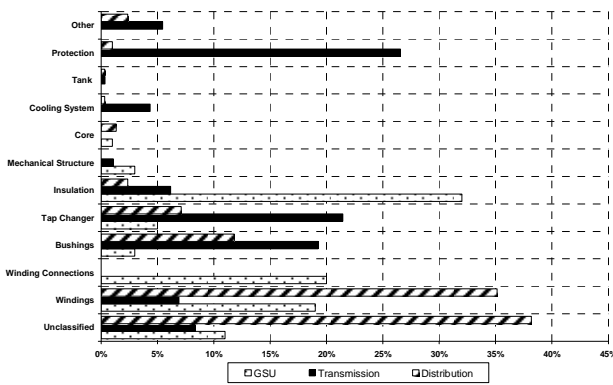
For the group of GSU transformers, failures originating in the transformer insulation are the largest contributors, followed by the windings and winding exit leads, as shown in Figure 2.

Figure 2: Failure locations in GSU, transmission and distribution transformers

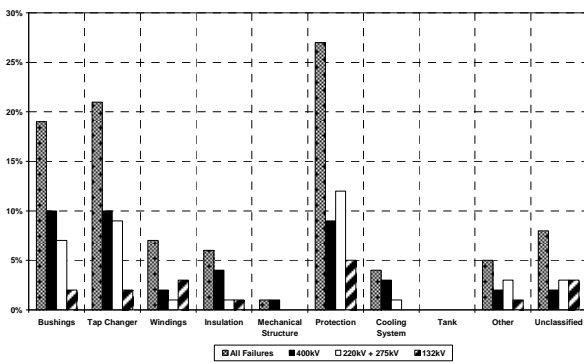
Figure 3: Failure locations in transmission transformers according to voltage level

While protection is shown as the highest contributor among the transmission failures, tap changer and bushing failures dominate, particularly in the higher voltage (220 ~ 400kV) range, as shown in Figure 3. Failures occur across all age group up to 43 years in service.

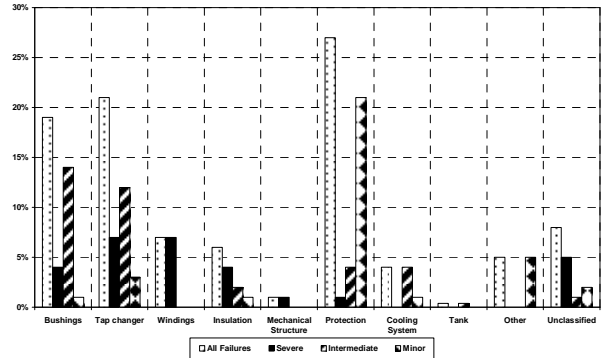
protection, and tap changer pressure relief and surge protection, are the largest contributor, making up 27% of all failures. Almost all these failures are minor failures, as shown in Figure 4.

Failures originating in the tap changer are predominantly in the higher voltage ranges and of the intermediate and severe type.

Figure 4: Failure locations according to failure severity

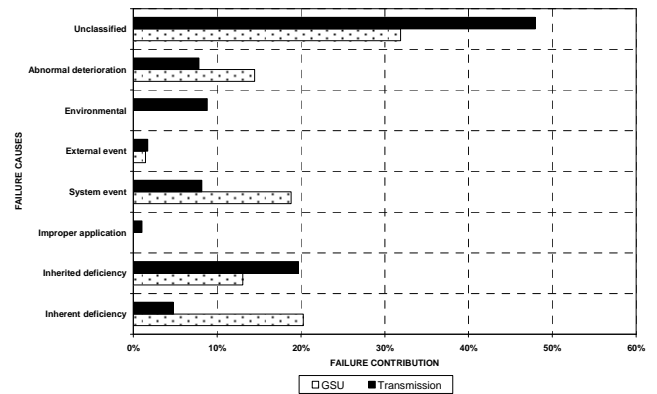
Figure 5: Failure cause distribution of GSU and transmission transformers

Failures due to inherent deficiencies make up most of the GSU failures, followed by inherited deficiencies, system events and abnormal deterioration.

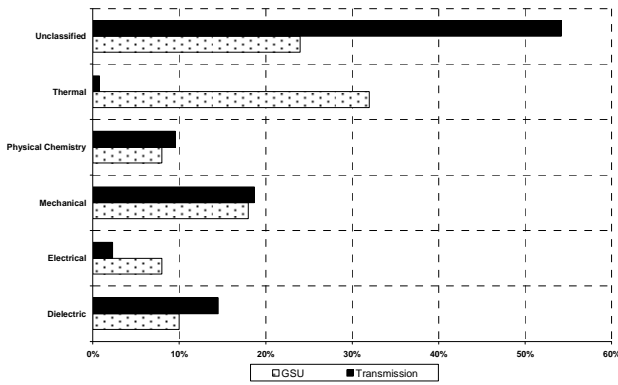
Thermal mode failures are the most prominent among *GSU transformers* occurring after 14 - 36 years in service, as shown in Figure 6. Most of these failures develop as localised hotspots in winding exit leads and winding turn insulation due to inadequate design.

Figure 6: Failure mode distribution for GSU and transmission transformers

With the *transmission failures*, mechanical mode failures were the largest contributor and more prominent in tap changer, bushings, windings and the cooling system, as shown in Figure 6. In these components they have resulted in breaking, loosening and displacement, caused by either improper maintenance, repair or factory assembly.
